**SL 123  
SL 096/25-005  
FAA AD 2024-26-02 (Pacific Scientific Seat Restraint System)**

**SUBJECT:** FAA AD 2024-26-02 – Pacific Scientific Company Seat Restraint System Rotary Buckle Assemblies

**MODELS AFFECTED:** All MU-2B Airplanes

### **Airworthiness Directives; Various Airplanes and Helicopters**

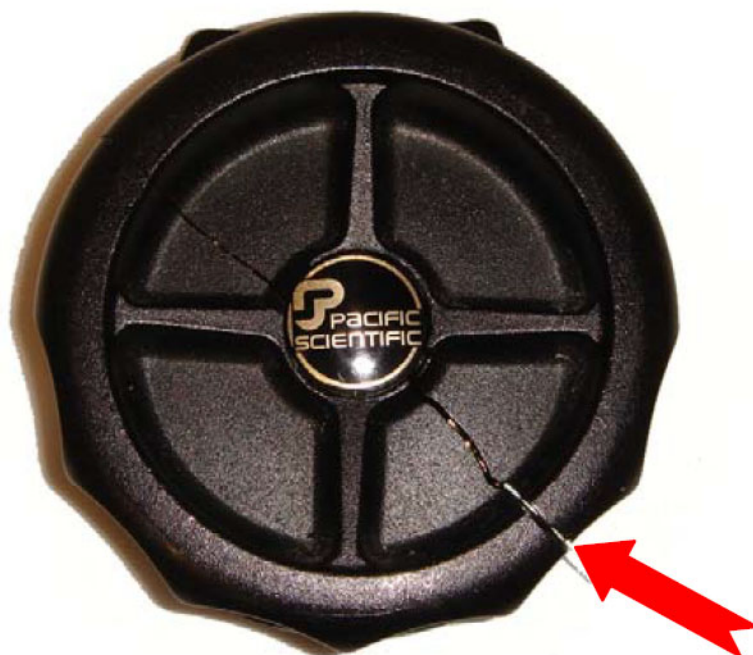
**Figure 1**  
*PNR 1111430-XX and PNR 1111475-XX Suspect Buckle Assembly*

- (a) In review and analysis of the evidences and data gathered from the investigation, Parker Meggitt had determined that this cracking is caused by a material process issue, and suspect handles are subject to removal from service in 2007.

NOTE 1 : Suspect handles may also be identified by measuring the thickness of the handle vane. Refer to Figure 1 as an example of a suspect buckle assembly with a crack.

NOTE : Any buckle assemblies with a cracked handle vane should be removed from service immediately.

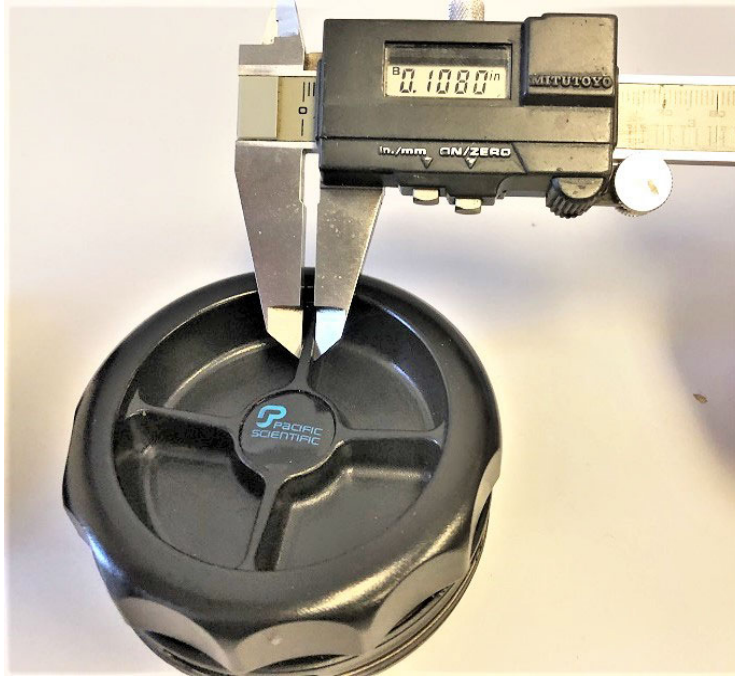
**Figure 3**  
*Correct Buckle Measurement*

- (2) If the thickness of the handle vane is greater than 0.125 inches at the top edge, then the buckle assembly is not compliant to FAA AD 2021-07-13 per AMOC dated June 29, 2021.

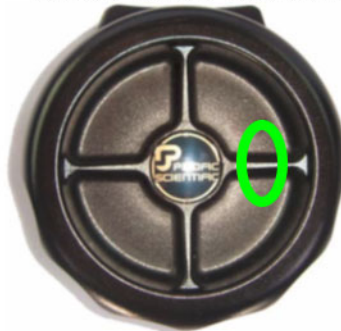
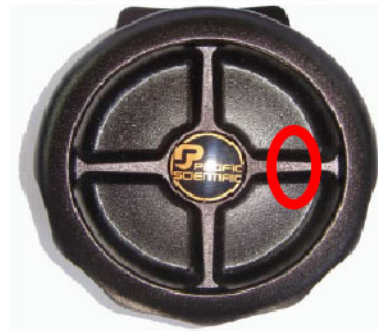
**Figure 4**  
*PNR 1111430-XX and PNR 1111475-XX Suspect Buckle Assembly*

**ACCEPTABLE HANDLE**

**SUSPECT HANDLE**

**ACCEPTABLE HANDLE:  
LESS THAN OR  
EQUAL TO 0.125 INCH**
