MITSUBISHI SERVICE PUBLICATIONS TRANSMITTAL

**FAA AD 2025-16-09 – Pacific Scientific Company Seat Restraint
System Rotary Buckle Assemblies**

SERVICE LETTER

SUBJECT: FAA AD 2025-16-09 – Pacific Scientific Company Seat Restraint System Rotary Buckle Assemblies

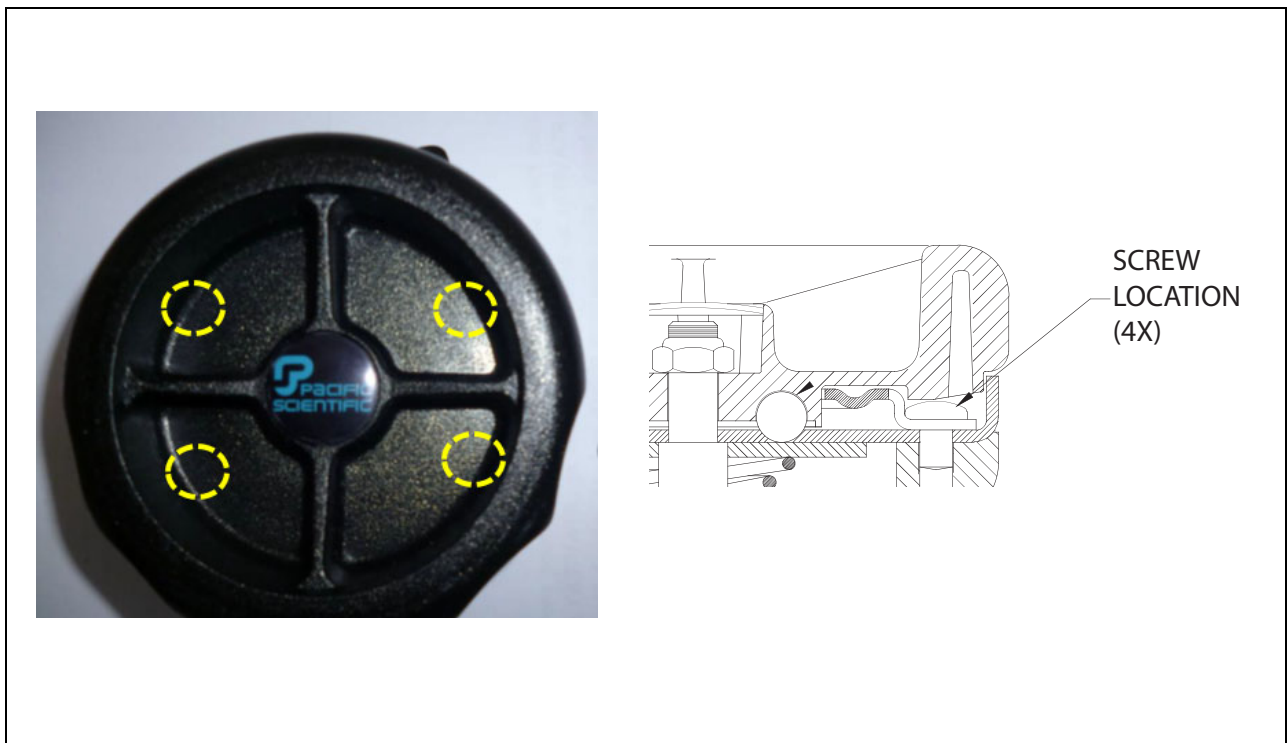
Figure 3
PNR 1111475 Series Rotary Buckle Screw Location

- (1) Use an inspection light to look through the belt openings in the rotary buckle. Refer to Figure 3 and Figure 4 on page 16 to locate the screws.
- (2) Inspect for the presence of 2 screw heads each on the left side and the right side of the buckle. Refer to Figure 5 on page 16.

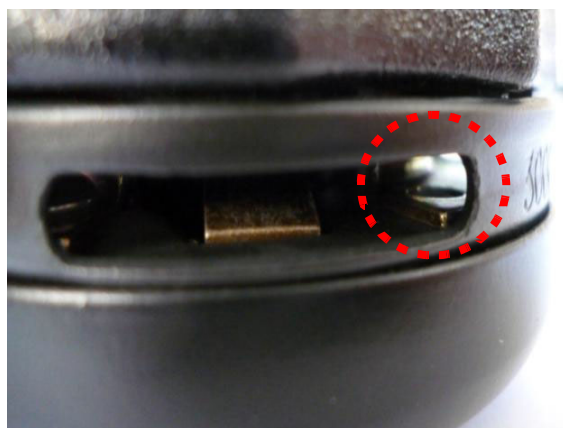
Figure 5
PNR 1111475 Series Rotary Buckle Screw Head

Missing Screw Head

Intact Screw Head

- (3) If any screw head is not present or is separated or not attached to the screw shank in the buckle :
- (a) Remove the buckle from service immediately. Refer to the procedure in section C. to remove the buckle from the restraint system.
 - (b) Replace the buckle with a new item. Refer to the procedure in section E. to install the new buckle in the restraint system.
 - (c) Send the damaged buckle back to Parker Meggitt for repair. Refer to section F. for contact information.
- (4) If the screw heads are intact, do one of the three following methods to determine if the screws are Torx head (alloy steel) or hex head (stainless steel) screws :
