SERVICE LETTER

SUBJECT: FAA Special Airworthiness Information Bulletin (SAIB) 2026-10R1 – Restraint Systems

MODELS AFFECTED: All MU-2B Airplanes

SPECIAL AIRWORTHINESS INFORMATION BULLETIN

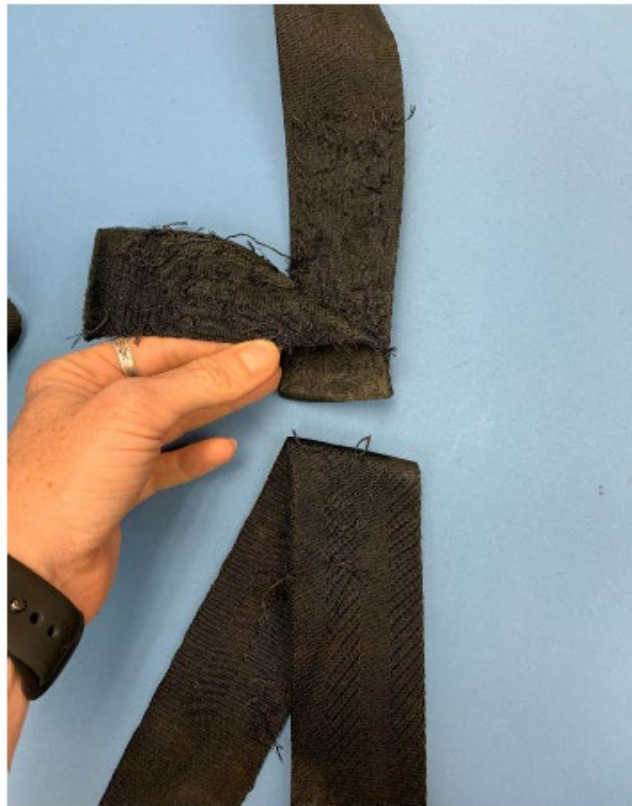
A search of NTSB public dockets identified at least fifteen other general aviation accidents resulting in full or partial failure of the occupants' restraint system. Many of these failures occurred at the Y-junction threading as shown in Figure 2. These accidents often involved serious or fatal injuries of the occupants. Further inspection of the accident findings revealed that these restraints are often designed to obsolete TSO requirements. Minimum torso restraint system performance requirements are currently prescribed in [TSO-C114](#) dated March 27, 1987. Minimum safety belt performance requirements are currently prescribed in [TSO-C22g](#) dated March 5, 1993. Both TSOs provide standards equivalent to SAE Aerospace Standard (AS) Document No. AS8043, "Torso

Figure 2
Four-point restraint assembly with separation at shoulder harness Y-junction threading

- Perform routine preflight and annual visual inspections of both the shoulder and pelvic restraints to check for signs of wear, deformation, discoloration, defects, or fraying. Special attention should be paid to the threading on the Y-junction that separates the two shoulder straps and connects to the fuselage attach strap behind the occupant’s head as well as the fastener hardware.
- Report findings of damage to the FAA point of contact. Please include the make, model, and serial number of the restraint and aircraft; a description of the damage; photographs; recommended inspection techniques to locate the damage; the damaged parts’ time in service; and any other information that may assist in our evaluation of this issue.

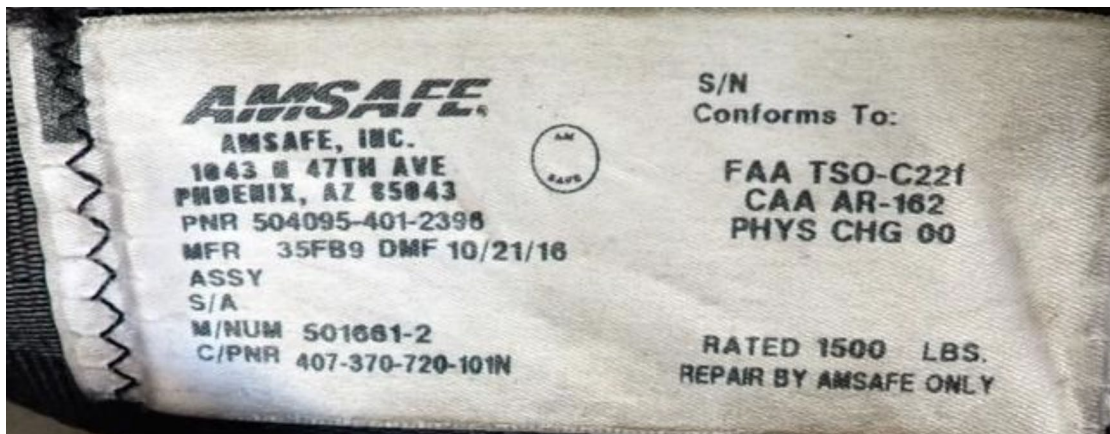
- Positively identify that their restraints meet these minimum performance requirements through visual inspection of the manufacturer’s label markings on the restraint assemblies. These markings may list the TSO numbers and/or the rated strength of the restraint assembly. The assembly’s rated strength to meet the current performance requirements is 3000 lbs or more. Figure 3 and Figure 4 show examples of label markings of restraints which do and do not meet TSO-C114 or TSO-C22g requirements.

Figure 4
 Example label marking of restraint that does not meet TSO-C114 or TSO-C22g requirements

- Replace torso and pelvic restraints which are not labeled as meeting TSO-C114 or TSO-C22g or later revisions, respectively; which do not meet or exceed an assembly rated strength of 3000 lbs or more; or which have a missing, illegible, or unreadable label or marking on the restraints with restraints which meet these TSO minimum performance requirements.
