**SL 123  
SL 096/25-005  
FAA AD 2024-26-02 (Pacific Scientific Seat Restraint System)**

**SUBJECT:** FAA AD 2024-26-02 – Pacific Scientific Company Seat Restraint System Rotary Buckle Assemblies

**MODELS AFFECTED:** All MU-2B Airplanes

### **Airworthiness Directives; Various Airplanes and Helicopters**

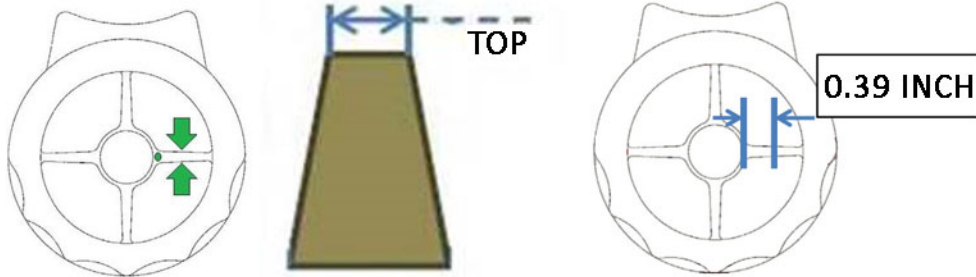
**Figure 3**  
*Correct Buckle Measurement*

- (1) Measure the handles in accordance with Figure 3 on page 20 and Figure 4 on page 20 to make sure the handles are less than 0.125 inches at the top edge. Parker Meggitt has created an optional inspection tool (PNR 1111432-GA). Contact Parker Meggitt for purchase of the inspection tool. Refer to Figure 5 on page 21 for correct use of the optional inspection tool.

**ACCEPTABLE HANDLE**

**SUSPECT HANDLE**

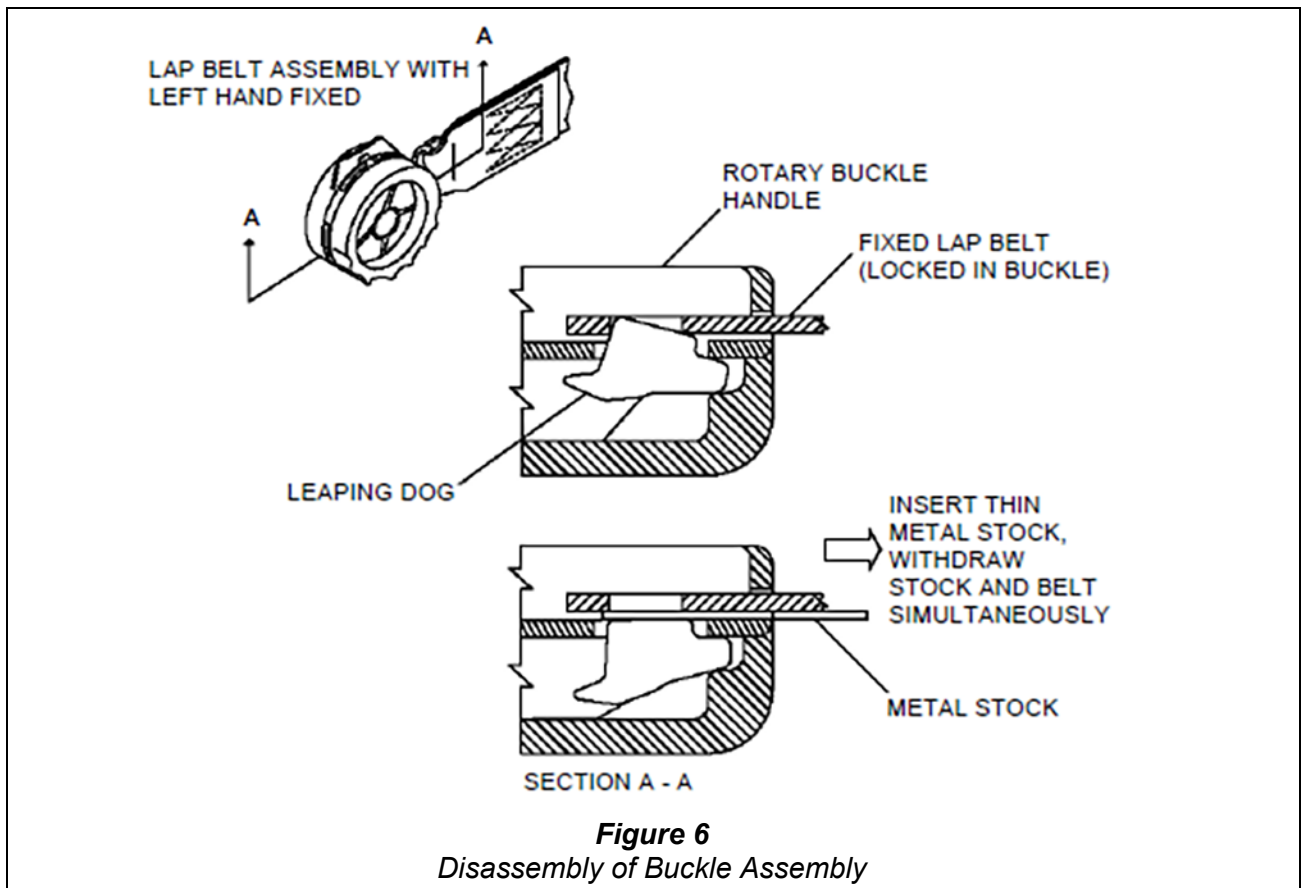
- (1) Insert a piece of thin metal stock into the slot of the rotary buckle and push inward between the fitting and the buckle locking mechanism (refer to Figure 6).
- (2) Pull the fitting from the buckle.
- (3) Remove the buckle pad as necessary.

- (1) Insert lap belt fitting into new buckle.

NOTE : Fixed strap location is indicated by appropriate marking on buckle housing.

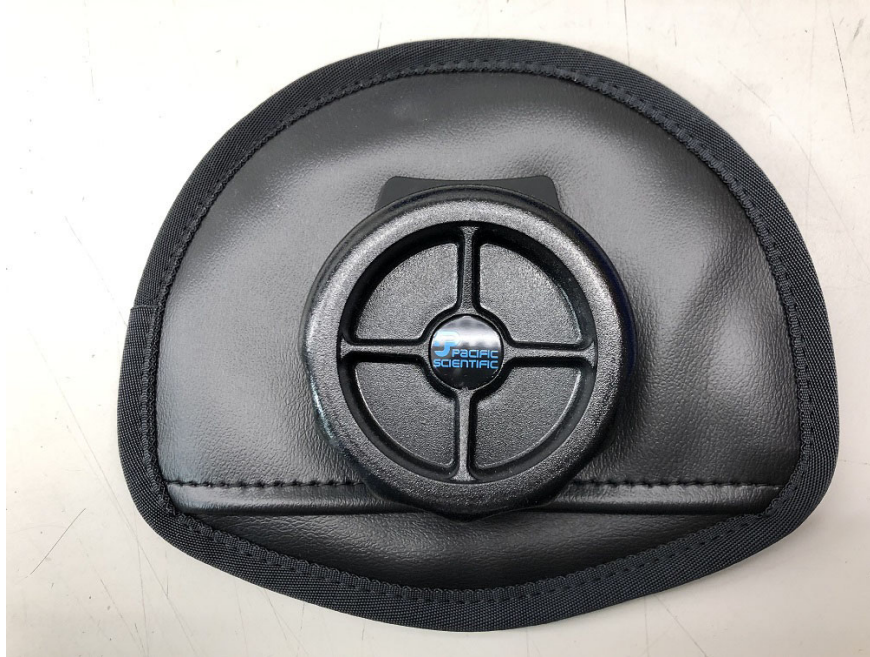
**Figure 1**  
Rotary Buckle with Buckle Pad

- A. For Rotary Buckles with a Buckle Pad: DOM information can be found inside the Buckle Pad, directly behind the Rotary Buckle as shown in Figure 1 and Figure 2.
- B. For Rotary Buckles without a Buckle Pad: DOM information can be found on the rear of the Rotary Buckle as shown in Figure 3 and Figure 4.
