MITSUBISHI SERVICE PUBLICATIONS TRANSMITTAL

**FAA AD 2025-16-09 – Pacific Scientific Company Seat Restraint
System Rotary Buckle Assemblies**

SERVICE LETTER

SUBJECT: FAA AD 2025-16-09 – Pacific Scientific Company Seat Restraint System Rotary Buckle Assemblies

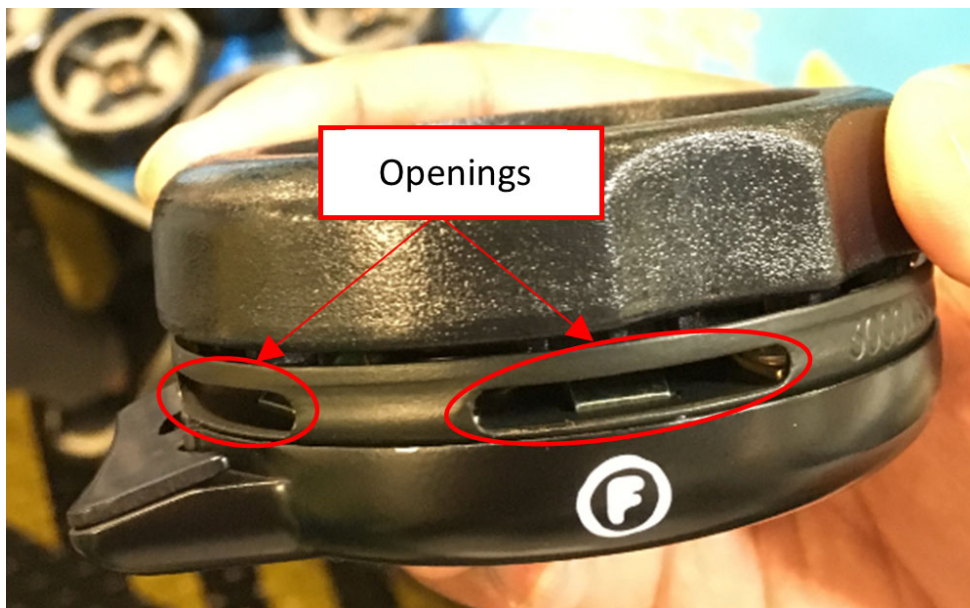
Figure 4
PNR 1111475 Series Rotary Buckle Openings for Inspection

- (1) Use an inspection light to look through the belt openings in the rotary buckle. Refer to Figure 3 and Figure 4 on page 16 to locate the screws.
- (2) Inspect for the presence of 2 screw heads each on the left side and the right side of the buckle. Refer to Figure 5 on page 16.

- (3) If any screw head is not present or is separated or not attached to the screw shank in the buckle :
- (a) Remove the buckle from service immediately. Refer to the procedure in section C. to remove the buckle from the restraint system.
 - (b) Replace the buckle with a new item. Refer to the procedure in section E. to install the new buckle in the restraint system.
 - (c) Send the damaged buckle back to Parker Meggitt for repair. Refer to section F. for contact information.
- (4) If the screw heads are intact, do one of the three following methods to determine if the screws are Torx head (alloy steel) or hex head (stainless steel) screws :

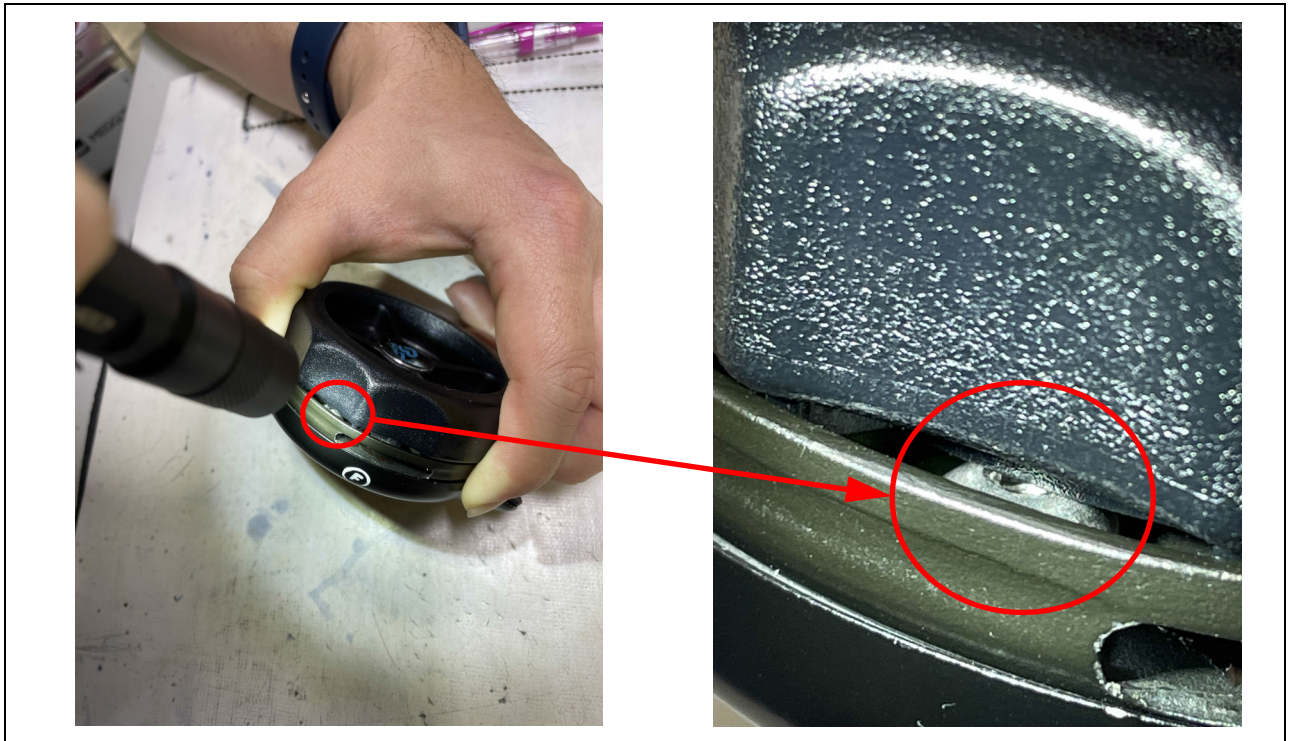
Figure 8
Side Belt Opening Inspection

- 1 Use an inspection light (100+ lumens light with eye loupe recommended) to look through the aperture between the handle and the non-rotating portion of the buckle (Figure 8) and inspect the screws to determine whether they have Torx heads or hex heads. The handle will need to be rotated slightly to provide the best view of the two lower screws and rotate fully to view the top screws. All screws will be in the same configuration within the affected production window. Refer to Figure 9 on page 20 to distinguish the screw head types.

- 1 Disassemble the rotary buckle. Refer to 4.C. on page 21.
 - 2 Reassemble the rotary buckle if the screws have hex heads. Refer to 4.E. on page 26.
- (5) If the screws have Torx heads (PNR 0901101-123), the buckle may remain in service temporarily, but the screws should be replaced as convenient to the operator. Refer to the procedure in section 4.D.(1) on page 23 to replace the screws.
