SERVICE LETTER

SUBJECT: FAA Special Airworthiness Information Bulletin (SAIB) 2026-10R1 – Restraint Systems

MODELS AFFECTED: All MU-2B Airplanes

SPECIAL AIRWORTHINESS INFORMATION BULLETIN

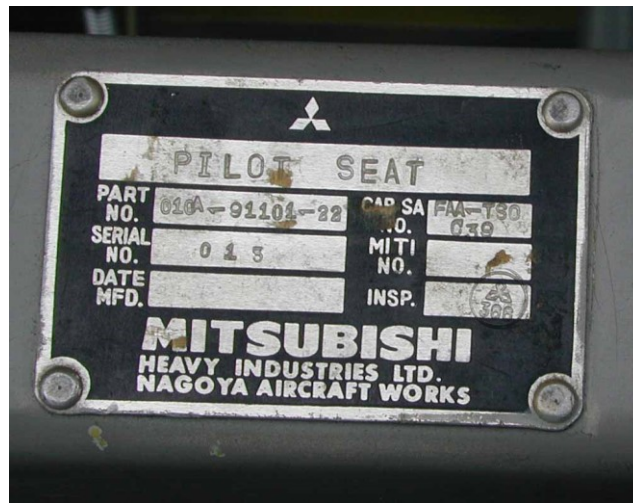
FIGURE 1 PILOT SEAT ID PLATE

The STC is applicable to the Tenryu and MHI seats installed in the MU-2B aircraft. Please verify the actual part number of the seats in your airplane, as they are physically interchangeable. Seat ID plates are located on the aft side of the seat-leg assembly as shown in Figure 1. Please contact your local MHIA Authorized MU-2 Service Center to order the applicable STC installation. The Service Centers will need to know the applicable seat part number, aircraft serial number, and webbing color. In addition, this STC provides the necessary installation instructions for an oxygen mask holder on the back of the seats.

MHI Pilot Seat Assembly PN 010A-91101-XX

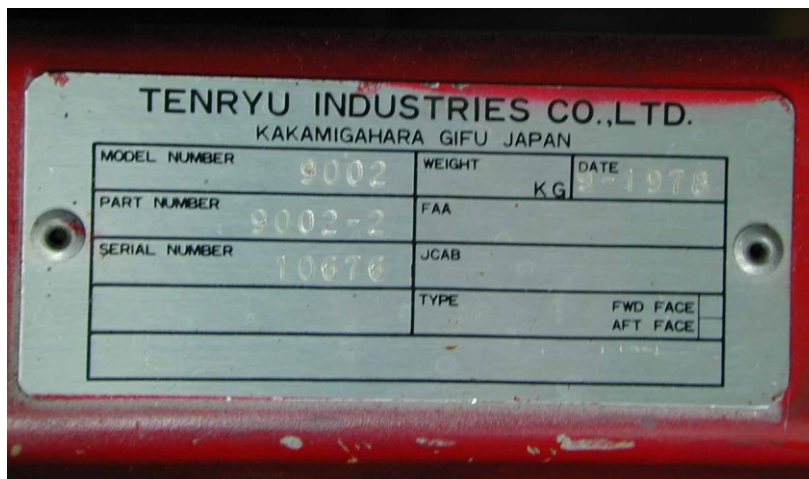
Tenryu Pilot Seat Installation PN 037A-91120-XX
(Tenryu Pilot Seat Assembly PN 9002-X)
