**SL 122
SL 095/34-004
FAA SAIB 2024-07 – Stall Warning System**

SUBJECT: FAA SAIB 2024-07 – Stall Warning System

MODELS AFFECTED: All MU-2B series aircraft

SUBJ: STALL WARNING SYSTEM, Angle of Attack Alerting Systems

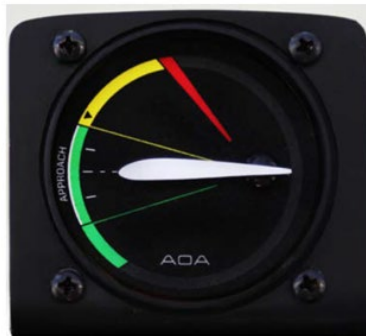
A more common method to display AOA is using a round dial. See figure 4. One of the most basic way is to present the actual degrees or the angle of the relative wind in relation to the chord reference line of the wing. Other scales use normalized units that range from “0” for zero AOA to “1” as the critical AOA.

Figure 4 – Basic AOA Indicator¹²
